Mobile Intel® Pentium® 4 Processor-M

Specification Update

October 2003

Document Number: 250721-019

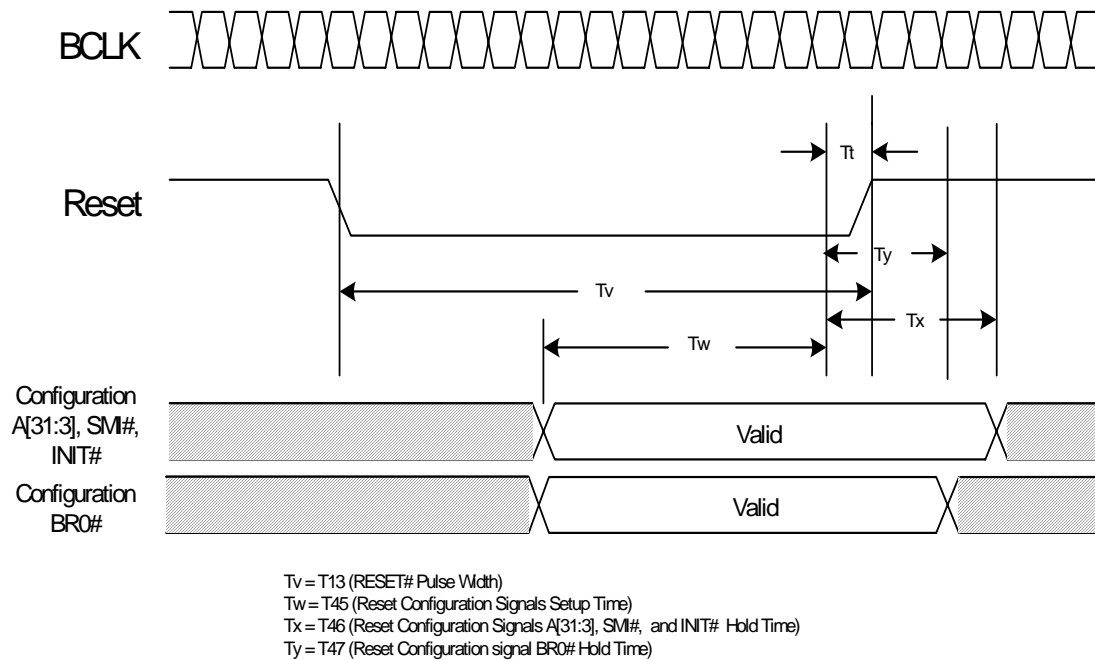
Figure 13. System Bus Reset and Configuration Timings

The BR0# maximum hold time has changed to 2 BCLKs. This change will be shown in the “System Bus AC Specifications (Reset Conditions)” table and “System Bus Reset and Configuration Timings” figure of the *Mobile Intel® Pentium® 4 Processor - M Datasheet*. This change will be incorporated in the next revision of the datasheet.
